# **WEAR ANALYSIS OF DIESEL ENGINE FUEL INJECTION PUMPS FROM MILITARY GROUND EQUIPMENT FUELED WITH JET A-1**

**INTERIM REPORT  
BFLRF No. 272**

**Belvoir Fuels and Lubricants Research Facility (SwRI)  
Southwest Research Institute  
San Antonio, Texas**

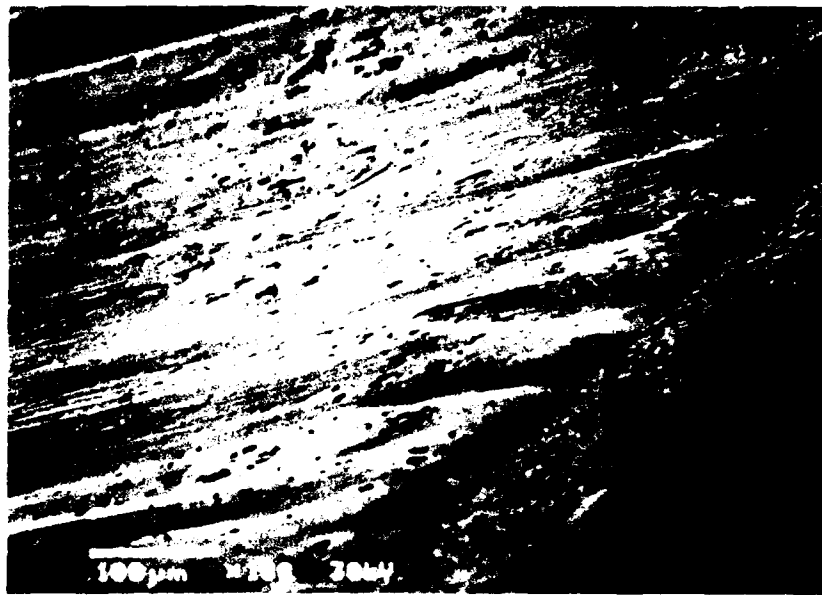
**Figure 2. SEM micrograph taken at edge of wear scar on face of transfer pump vanes**

The rotor was seized close to the transfer pump, and the drive shaft was sheared. Slight discoloration of the rotor had also occurred close to the pumping plunger end. The transfer pump blades and liner were severely worn, probably equivalent in civilian vehicles to several hundred thousand miles of operation on diesel. The wear scar on the pump vanes was 32 micrometers

deep, with a Center Line Average (CLA) roughness of 1.21 micrometers. A Scanning Electron Microscope (SEM) micrograph taken at the edge of the wear scar is shown in Fig. 2. The step measured by the Talysurf profilometer may be seen toward the right of the figure. Longitudinal wear tracks were ploughed into the surface, and the very porous nature of the sintered material is clearly visible.

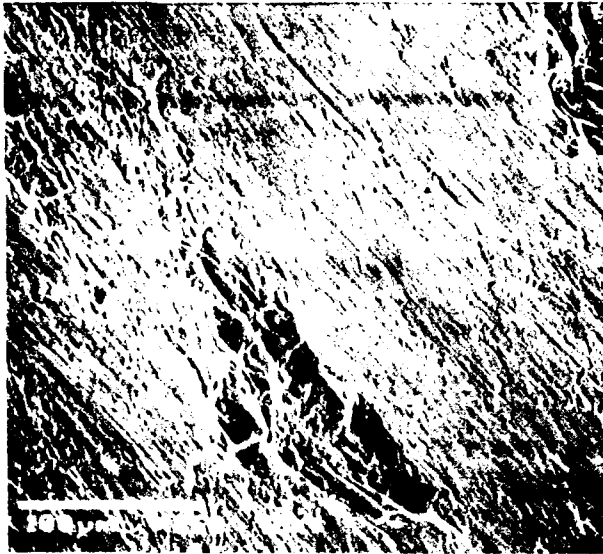
**Figure 3. SEM micrographs of transfer pump liner**

The transfer pump liner was discolored at the area corresponding to the fuel outlet port. The surface topography in this area was slightly pitted, with some evidence of plastic deformation as shown in Fig. 3a. Elongated wear tracks were formed on the surface of the liner emanating from the scuffed area, as shown in Fig. 3b. These tracks were probably cut by adhesive wear debris that was formed during scuffing.

Evidence of transient scuffing was visible on several transfer pump liners operated on Jet A-1. The surface of the scuffed liners was discolored and, in some instances, slightly pitted close to the fuel outlet ports, as shown in Fig. 3. The surface of a badly scuffed liner provided by the pump manufacturer is shown in Fig. 6. Considerable plastic deformation and surface pitting were present. These pits were probably formed by adhesive wear during lubricant failure and scuffing. Microscopic examination of the slightly scuffed liners from the current batch of pumps shows isolated areas with a similar but less severe wear mechanism.

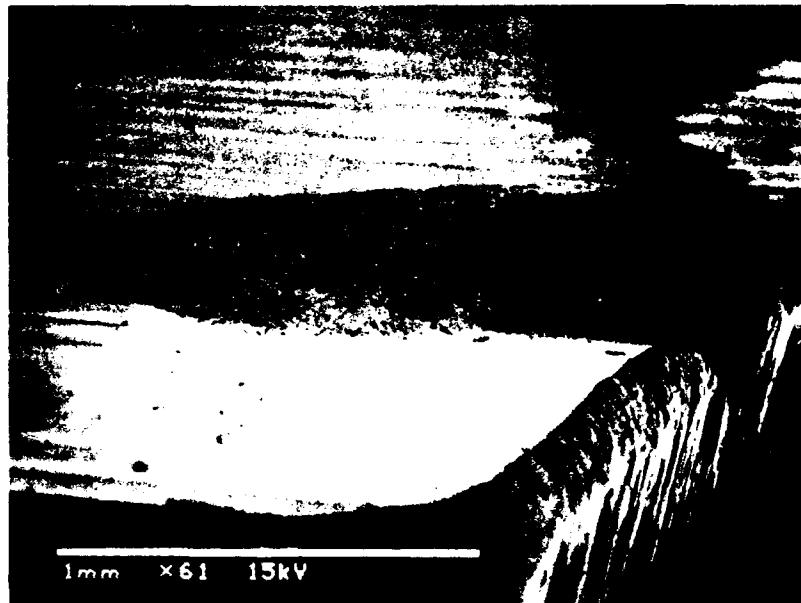
**Figure 4. SEM micrograph of chipped pump rotor**

small amount of metal had been chipped from the slots in the rotor, which retains the transfer pump vanes, as shown in Fig. 4. The location of the fractures coincided with the point of contact between the vanes and the rotor and was probably caused by severe side loading on the pump vanes. Such loading is known to cause seizure of the pump rotor.

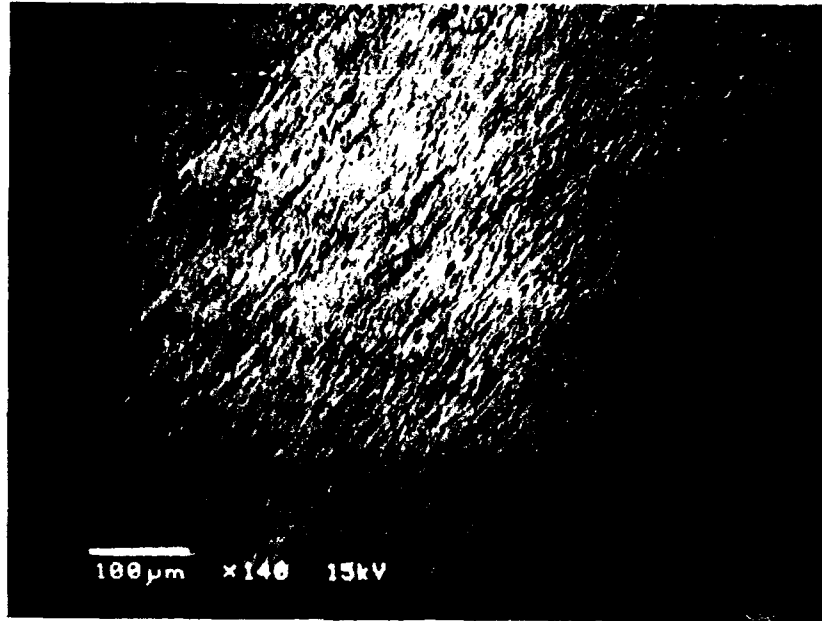
**Figure 5. SEM micrograph of worn area on upgraded (arctic) transfer pump vanes**

No drive shaft was provided, and the rotor was seized close to the transfer pump. Unlike previous pumps studied, the transfer pump was not severely worn; little visible wear was present on the vanes, and the contact area was smooth as shown in Fig. 5. As a result, no measurable wear scar could be located by the surface profilometer. The liner and retainers also showed little visible wear, although the liner was slightly blackened close to the outlet port. On the present pump (DC series), these components are fabricated from M-2 high-density steel, which corresponds to the arctic conversion kit for the DB2 pump.

One of the springs that maintain the position of the transfer pump blades had disintegrated, and the fragments were distributed throughout the pump. Loss of this spring may have caused the pump vanes to stick. In addition, fragments of metal from the spring may have interfered with the pump mechanism. The delivery valve spring was also broken, but the parts were contained within the valve. Seizure could be induced if the delivery valve stuck closed; however, the

seizure would probably be located close to the pumping plunger end of the rotor. It is more likely that loss of the delivery valve spring resulted in a deterioration of the injection characteristics.
