# **WEAR ANALYSIS OF DIESEL ENGINE FUEL INJECTION PUMPS FROM MILITARY GROUND EQUIPMENT FUELED WITH JET A-1**

**INTERIM REPORT  
BFLRF No. 272**

**Belvoir Fuels and Lubricants Research Facility (SwRI)  
Southwest Research Institute  
San Antonio, Texas**

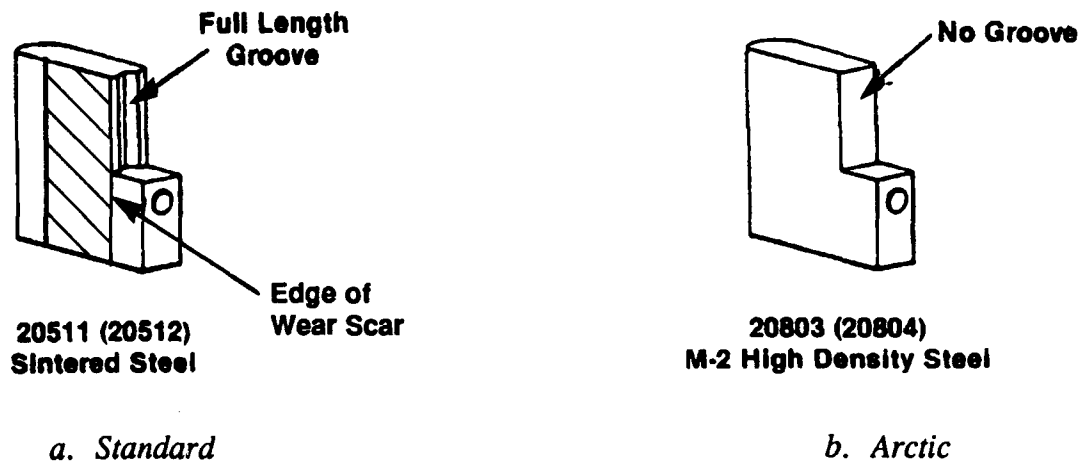
**Figure 1. Diagram of standard and arctic pump vanes**

The transfer pump section was previously demonstrated to be particularly susceptible to wear.(3) As a result, the transfer pump was the subject of a more detailed study in the present work. A reciprocating motion is formed between the rotor and the transfer pump blade. This action forms a wear scar with a sharp step at the limit of the cycle, at the position shown in Fig. 1. The depth

of the wear scar was measured at this step, using a Talysurf 10 profilometer. In addition, the surface roughness was measured across the sliding direction (parallel to the step). The profile was filtered with a cut off wavelength of 0.03 inches (0.76 mm) and a stylus tip dimension of 0.0025 mm. The results reflect the depth of the furrows ploughed in the surface of the blade by the wear mechanism.
